TOWN OF CHAPLIN

INSPECTION of BEDLAM ROAD BRIDGE over UNNAMED STREAM

Bridge No. 024004

MAY 20, 2019

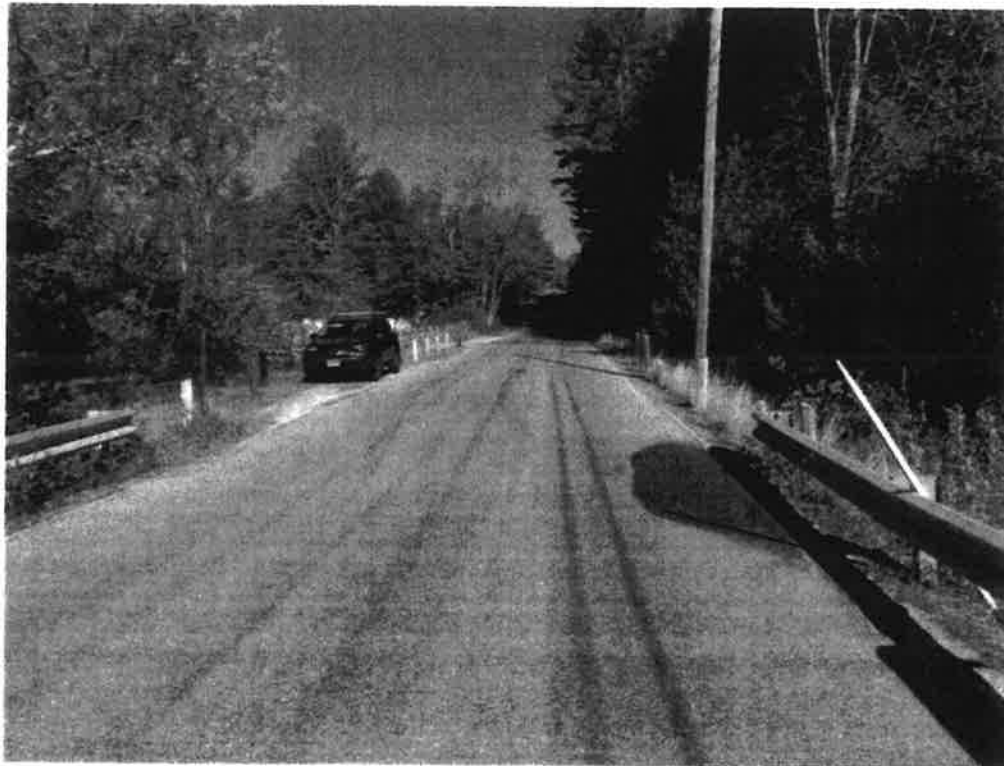
Photo 2 - West Approach to Bridge (Facing East)

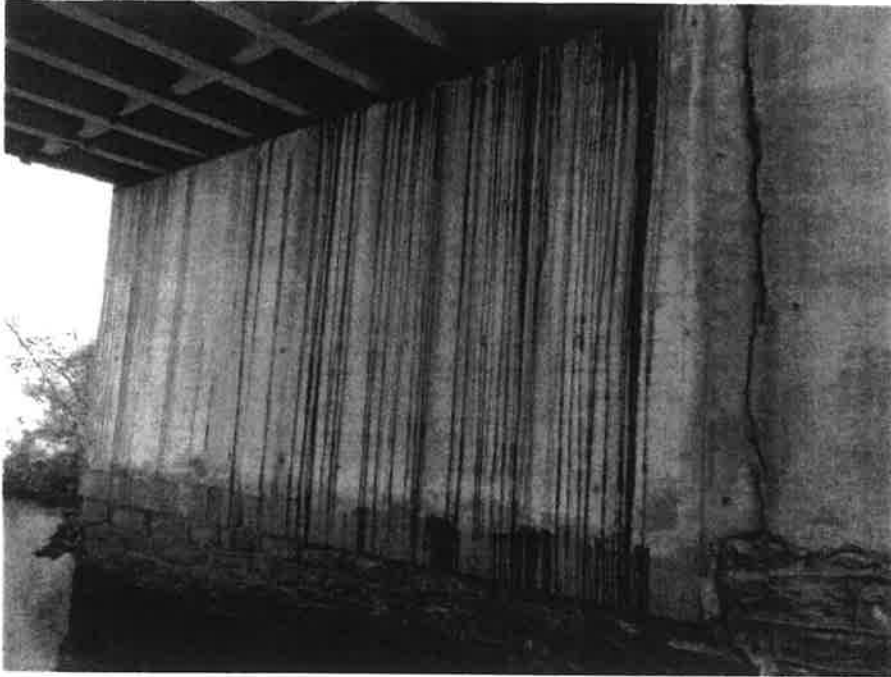
Photo 3 – West Abutment

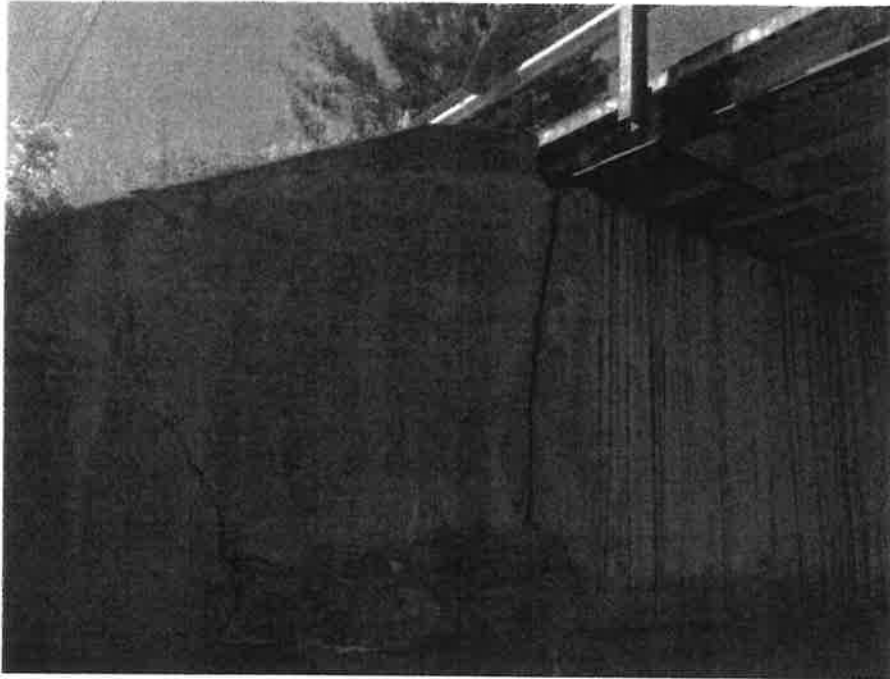
ABUTMENTS-STEM	<input type="checkbox"/> 3	Abutments have some missing mortar, minor effrescence and light scalling. All wingwalls have full height vertical carcks, in some parts about 3-4 inches wide with random spalls. There are full height vertical cracks causing separation between the wingwalls and west abutment.
ABUTMENTS-BACKWALL	<input type="checkbox"/> 4	There are cracks observed in backwall where it meets wingwalls and facia beams
ABUTMENTS-FOOTINGS	<input type="checkbox"/> 4	
ABUT.-SETTLEMENT	<input type="checkbox"/>	
ABUTMENTS-WINGWALLS	<input type="checkbox"/> 3	
PIERS/BENTS-CAPS	<input type="checkbox"/> N	
PIERS/BENTS-PILE BENT	<input type="checkbox"/> N	
PIERS/BENTS-COLUMN	<input type="checkbox"/> N	
PIERS/BENTS-FOOTINGS	<input type="checkbox"/> N	
PIERS/BENTS-SETTLEMENT	<input type="checkbox"/> N	
EROSION-SCOUR	<input type="checkbox"/> 4	On the east abutment downstream side and on west abutment upstream side about 4 feet deep. scour pools have been observed.

**Photo 5 – Northwest Corner/West Abutment
Large Vertical Crack and Tilted Wingwall**

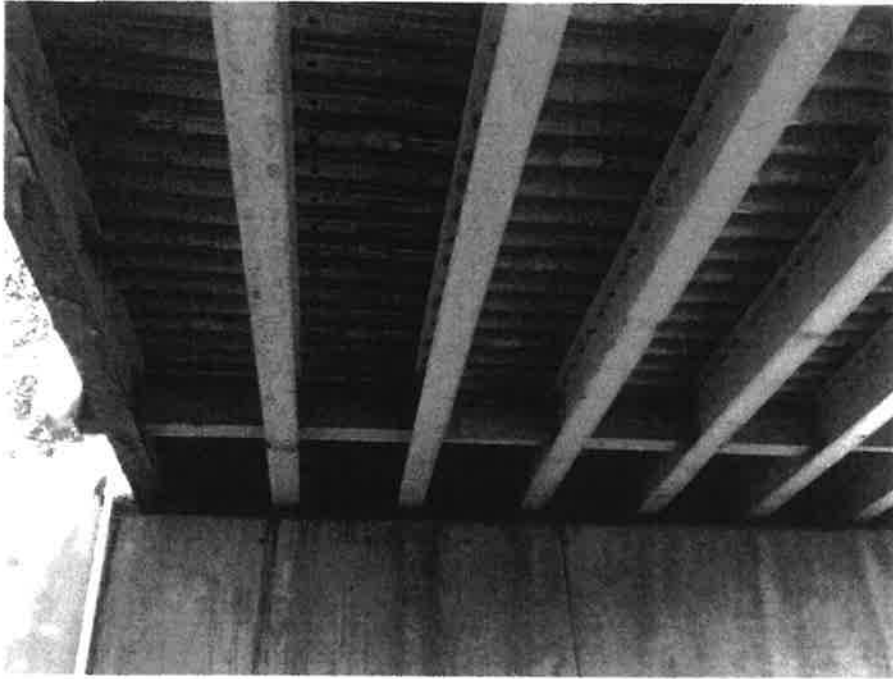
The Superstructure is in Fair Condition (Condition Rating = 5). It consists of a concrete deck slab. Both facial beams have rusting along the beams and moderate rusting at both ends due to moisture. No section loss was observed.

Photo 7 – Under the Bridge, Rusted Exterior Beam

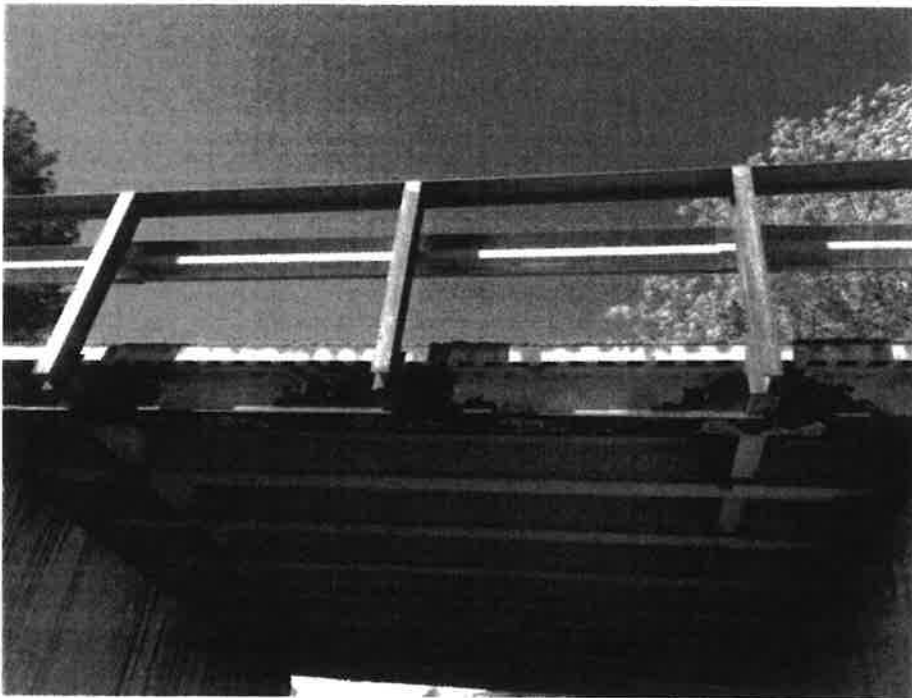
Photo 8 – Upstream Fac, Rusted Exterior Beam

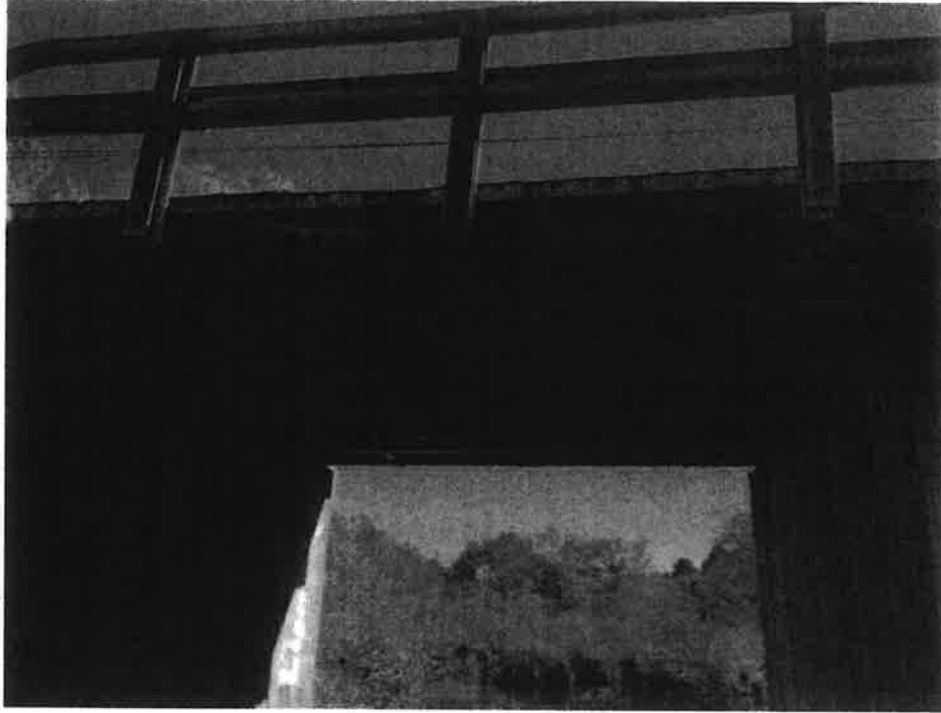
Photo 9 – Downstream Face (Looking Upstream)

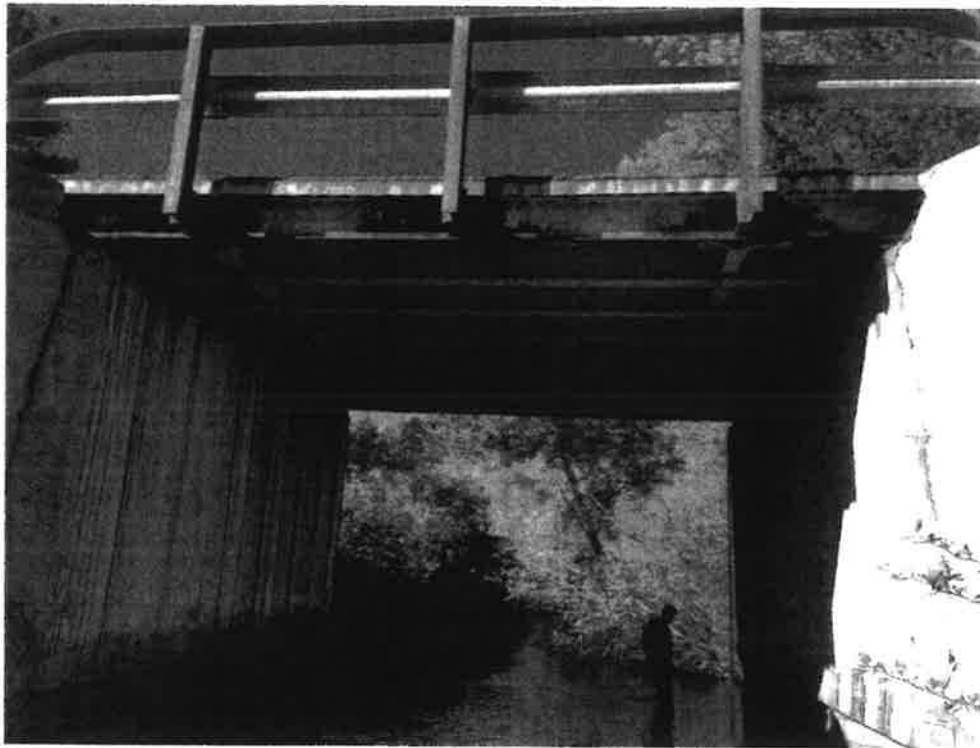
Photo 10 – Upstream Face (Looking Downstream)

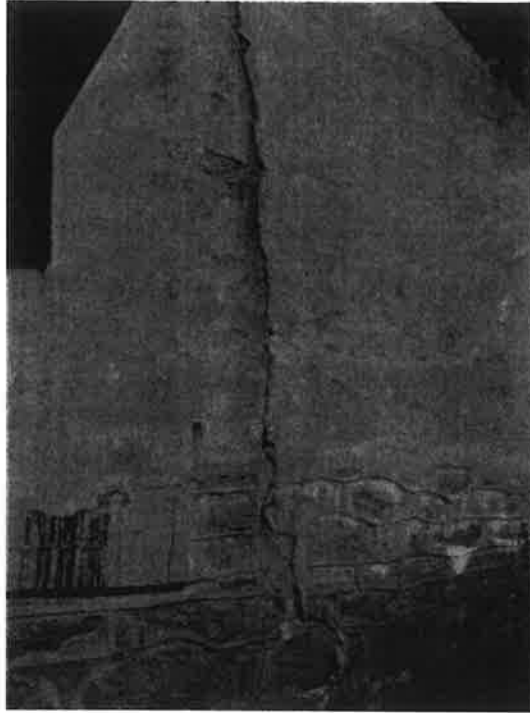
Photo 11 – Northeast Corner, Large vertical crack in the wingwall

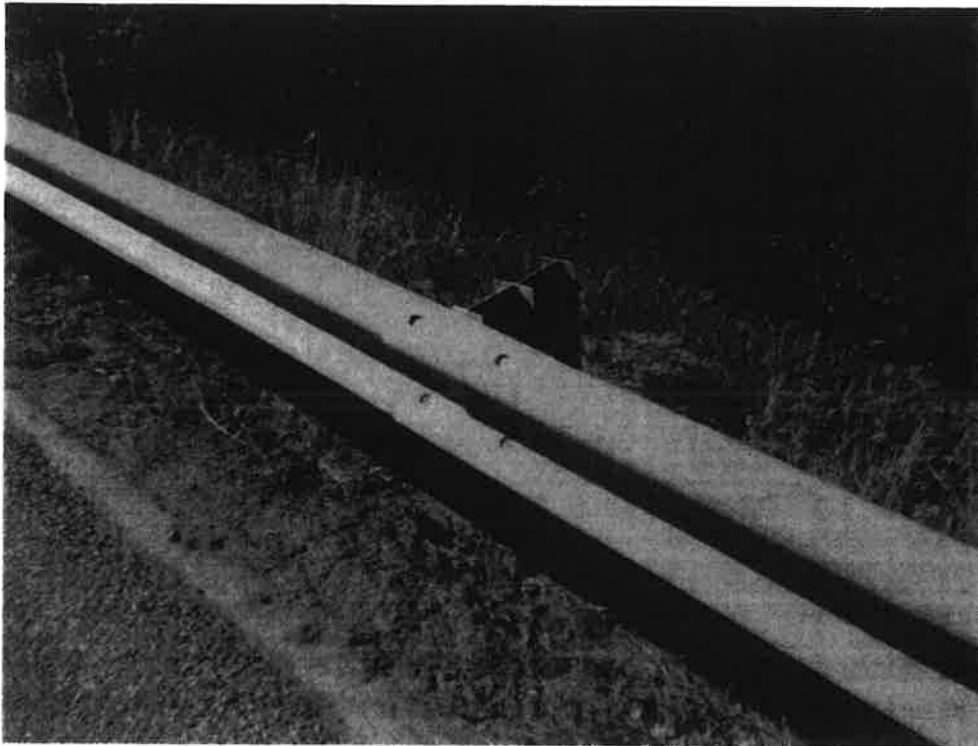
APPROACH CONDITION		OVERALL RATING	<input type="checkbox"/> 5
	RATING		
APPROACH SLAB	<input type="checkbox"/> N		
RELIEF JOINTS	<input type="checkbox"/> N		
APPROACH GUIDE RAIL	<input type="checkbox"/> 5	Guiderrails look entact but there are bolt and nusts missing almost in every piece connections.	
APPROACH PAVEMENT	<input type="checkbox"/> 6	Approach slab is satsifactory condition with minor longitudinal cracking.	
APPROACH EMBANKMENT	<input type="checkbox"/> N		
TRAFFIC SAFETY FEATURES:			
BRIDGE RAILINGS	<input type="checkbox"/> 5	Exhibit rust at the connections with facial beams.	
TRANSITIONS	<input type="checkbox"/>		
APPROACH GUARDRAILS	<input type="checkbox"/> 5	Guiderrails are missing bolt and nusts in connections.	
APPR. GUARDRAIL ENDS	<input type="checkbox"/> 5

Photo 13 – Guiderails Missing Bolts at Joints

Photo 14 – Guiderails Missing Bolts at Joints

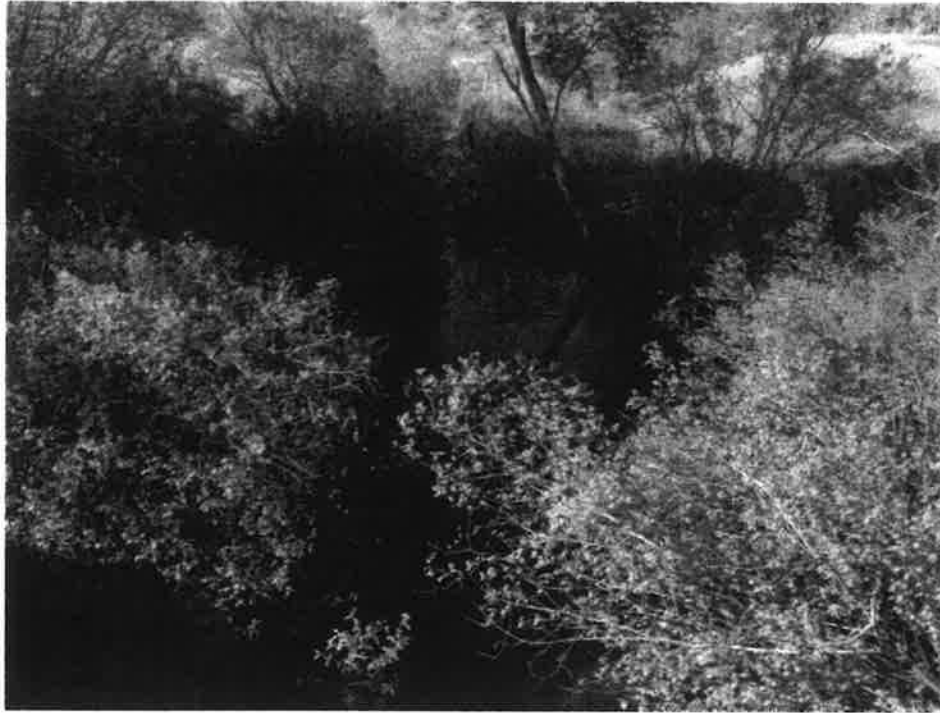
Photo 15 – Downstream (Looking from Top of Bridge)

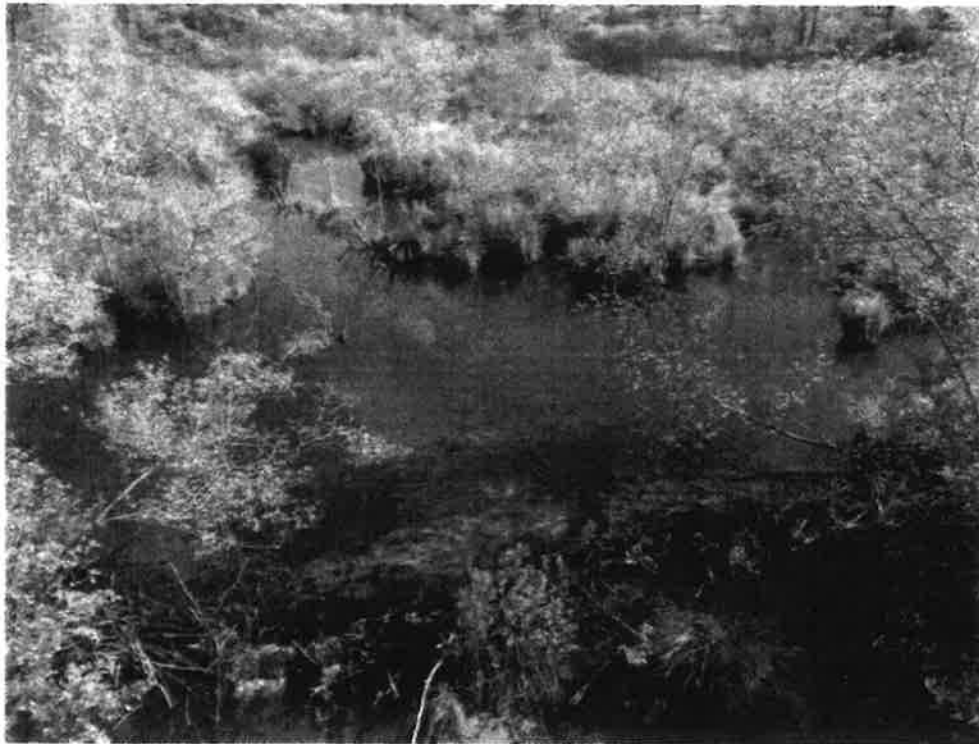
Photo 16 – Upstream (Looking from Top of Bridge)
